Removing Insistent Carbon Deposits on Diesel Engines

AT A GLANCE - TECHNICAL INFO

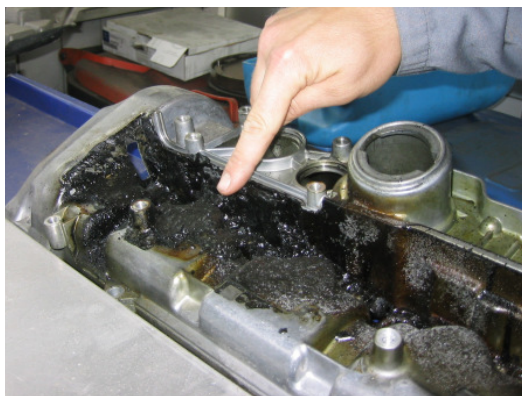
Common rail diesel engines often suffer from heavy contamination on the valve cover. Defective sealing rings on the seat of the injectors allow a mixture of diesel, soot and exhaust gas to escape. This then solidifies to form a stubborn crust (Fig. 1). These crusts sometimes cover the whole of the valve cover, often to a depth of several centimeters, and are as hard as coal.

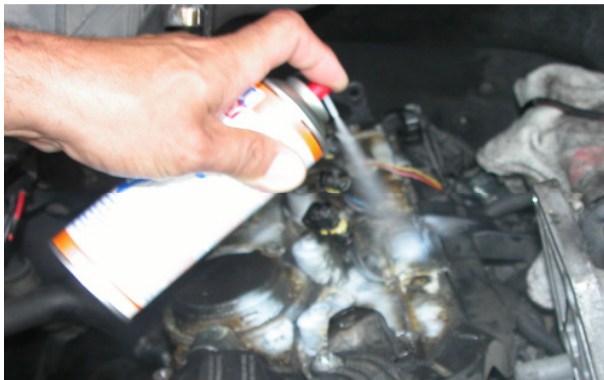
Spray all parts thoroughly with Sealant Remover and allow to work in.

Then spray the incrustated surface thoroughly with the Liqui Moly Sealant Remover. Allow to work in for 30 minutes or overnight if necessary. This dissolves and softens the crusts. If the incrustation is very deep, scrape off again using a screwdriver and then respray.

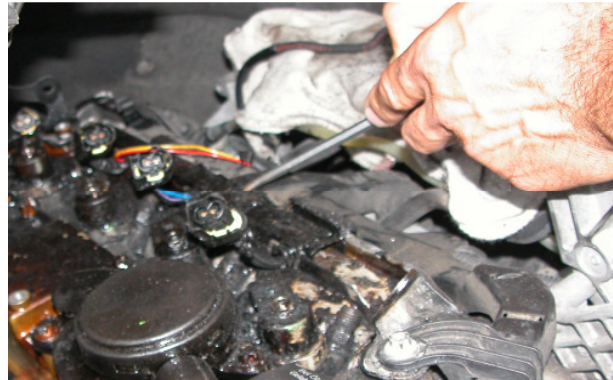
Scrape off and respray several times. Then give the engine a thorough wash.

Finally, give the engine a thorough hot wash with a high-pressure cleaner. The injectors can now be removed without any problem and also cleaned with Sealant Remover.

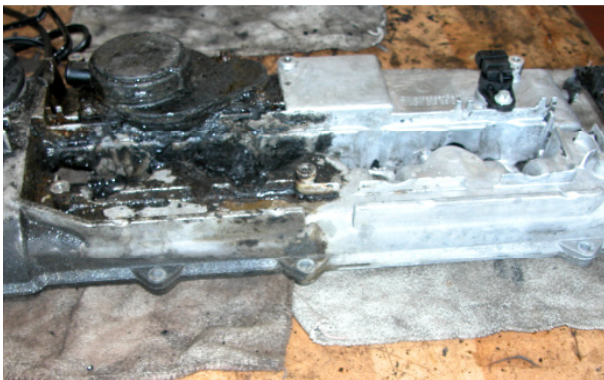
Removed valve cover. Left: untreated.
Right: cleaned with Sealant Remover and engine wash.

To free the engine from this extreme dirt and then replace the defective seals, lines, cables and especially the injector need to be removed. It may be necessary to disassemble the valve cover (Fig. 2).

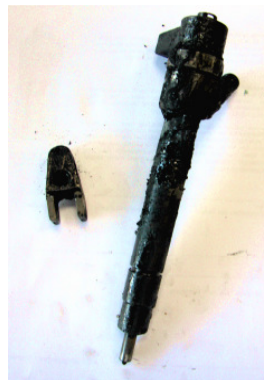
Removed injector with
hard incrustation.
